Siemens Transformers – Case study

# Reduced downtime thanks to TLM repair

## From outage to grid reconnection in just six weeks

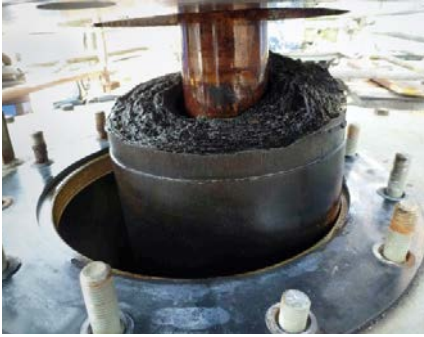
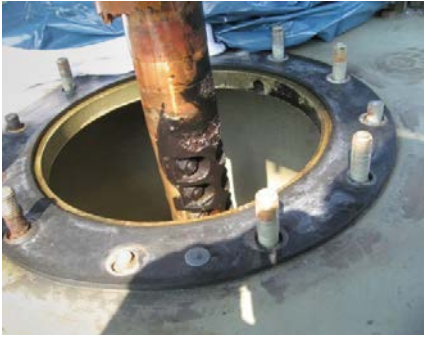
Defective bushing element and bushing pin

The arc in the bushing had caused an explosion of the capacitor element, which was split. This resulted in melting of the copper on the copper pin. The pressure of the evaporated oil exploded the element and bent the 80 mm thick copper pin.

With the exception of the damaged components, the overall condition of the transformer was evaluated as good. The electrode and lead were repaired and the bushing was replaced.

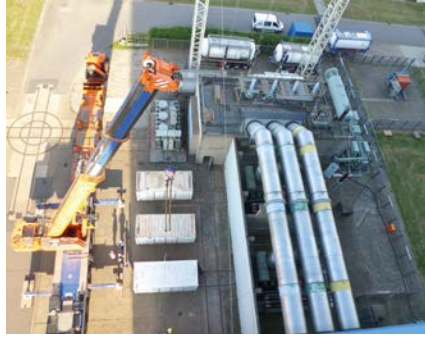
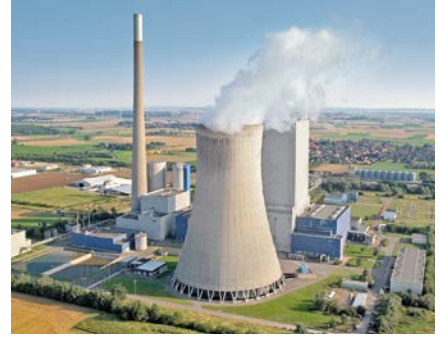
The experienced Siemens TLM repair team first performed a fact-finding inspection of the damaged area, then removed the dome and evaluated the condition of the removed parts. Various measures were implemented to upgrade the transformer, which was then professionally recommissioned. Only six weeks passed from the occurrence of the damage to reconnection of the power plant to the grid.
