Siemens Technical Bulletin STAB16-0101

Issue with recent batch of ST900/950ELV HPU boards

20th July 2016

Product: ST900/950ELV
Modifications Req: No
Retrospective Action Req: Yes
Priority of Change: Urgent ASAP

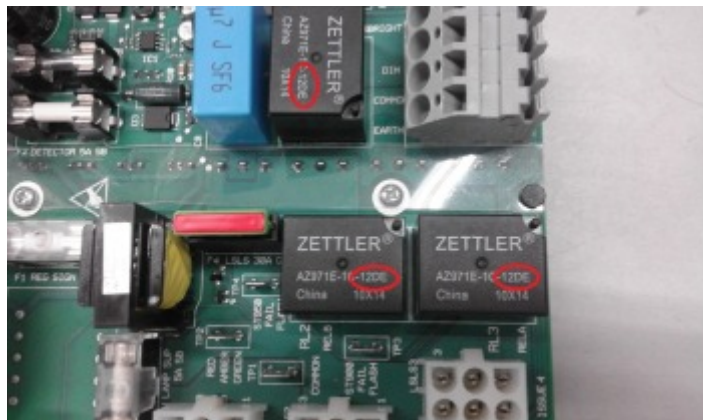
It has recently been found that there was a batch of ST900/950ELV HPU boards fitted with the wrong relays. The result of this error means that these HPU boards will eventually cause the CPUs boards to fail (FLF17) and in some cases this may cause heat damage to the pcb.

The HPU boards in question were built in early March and have 12V Relays fitted instead of 24V Relays. The figures below show how to identify the Relays on the HPU board.

Figure1: HPU board with 12V Relays fitted (shown as -12DE)

For any ST900/950ELV controllers commissioned in the last month and any that are being installed/commissioned in the next 3months, it is recommended to check the HPU board to ensure that it is fitted with 24V Relays. The longer the units with this error are left powered the more likely the HPU and CPU boards are to suffer non repairable damage.

Any HPUs (including those issued as spares) found with 12v Relays should be returned immediately to Poole for modification.

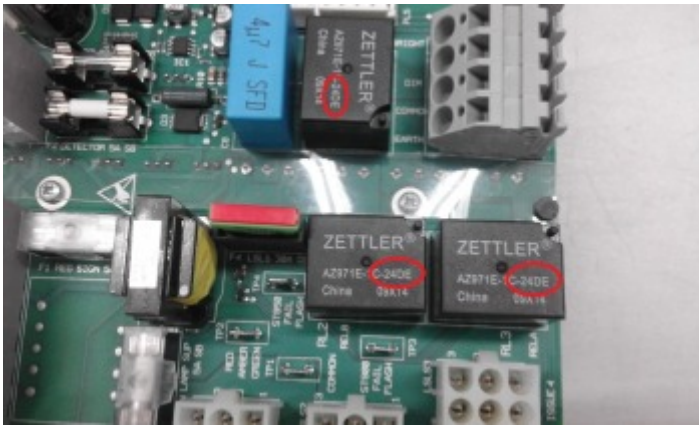
Figure2: HPU board correctly fitted with 24V Relays (shown as -24DE)
