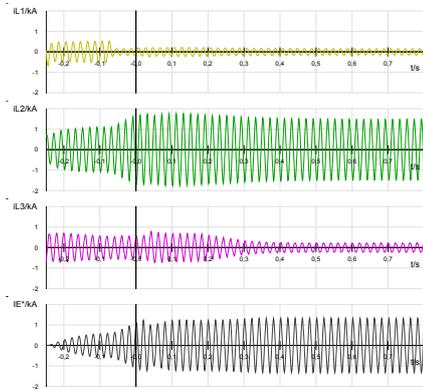
The on-site inspection revealed that the isolator of the bus coupler had closed only two contacts. The task was to verify that the interruption of a single pole could cause an overcurrent trip of the feeding transformer. This was achieved in a first step by analyzing the situation in symmetrical components.

Figure 2: Phase and earth currents for single pole interruption

By modeling the system afterwards in a software tool, it was possible to show that in networks with resonant earthing / grounding, single phase interruptions can lead to over-currents and even overvoltages. The result of the analysis was the basis to propose improved protection settings to eliminate such failures in future.

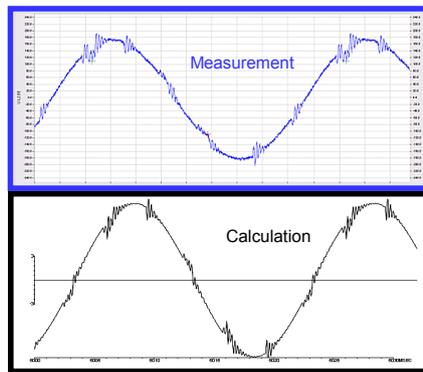
The trip of a low voltage drive resulted in an unsuccessful start-up process of a power station. Measurements showed a high level of voltage distortion under start-up conditions of the 6kV auxiliary bus. The distortion originated from the generator's start-up converter.

The simulation of the configuration with instantaneous values in PSS[®]-NETOMAC resulted in similar diagrams as shown in the measurements of the disturbance. This underlines the high quality of the model for the converter drive. The simulation was then used to investigate mitigation options.

Figure 3: Simulated and measured voltage

In addition to the well known, but expensive solutions such as filter circuits, it was possible to present an efficient, site specific solution. The installation of a series reactor resulted in reliable start-up in both the simulation and the real power plant.

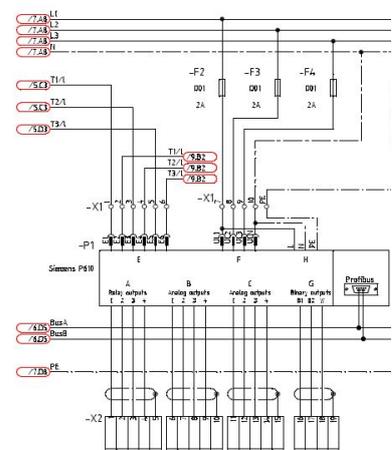
A trip signal of a bus bar differential protection caused a costly blackout of a liquid natural gas (LNG) plant, as all busses of a double bus bar system were affected.

The analysis on-site revealed that the switchgear was composed of two sections from different vendors and the protection concept was a third party engineering work.

By analyzing the fault records and local measurements, it was possible to reveal that the delay time of a single auxiliary contact started a crucial sequence of subsequent events. Defining a set of improved settings eliminated the cause of such failure events.

Figure 4: Secondary equipment configuration
