Aktuelle Einschränkungen/Besonderheiten im Gleisanschluss MMAL *Current restrictions/special features in the MMAL siding*

Anweisung Langsamfahrstelle auf dem Ostgleis (Gleis 5) im Bereich des Energiekanals

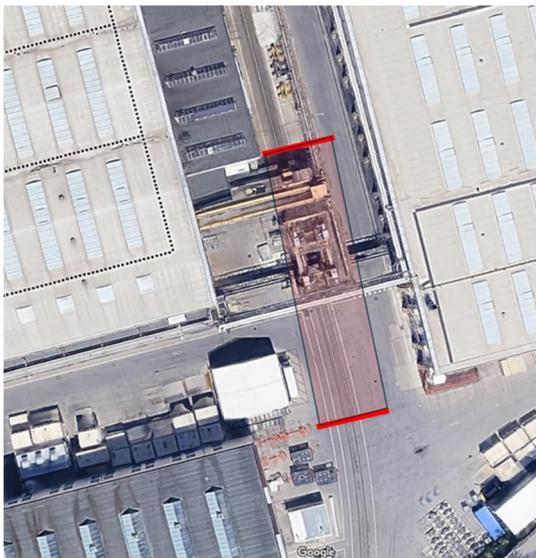
Aus aktuellem Anlass wurde im Absprache mit dem Statikbüro AJG eine Langsamfahrstelle im Bereich des Ostgleises (Gleis 5) definiert:

Nördliche Begrenzung: S/O Ecke von Gebäude 0261 bzw. Kransäule #40
südliche Begrenzung: Ende des Mehrspurgleises
V max: 3 km/h
Zeitdauer: Ab Aufhebung der derzeitigen Komplettspernung bis auf Widerruf
weitere Bestimmungen: kein Abstellen von Fahrzeugen in diesem Bereich
