Type TCP breaker maintenance program

Service solutions for your T&D infrastructure

Type TCP pneu-draulic circuit breaker major maintenance program

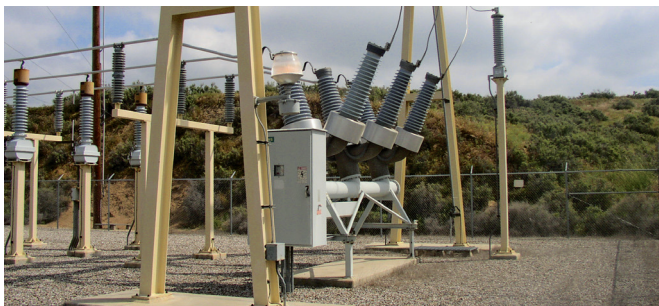
Siemens TCP145 kV 40 kA SF₆ circuit breaker

- **Interrupting rating**
Many 121 145 kV TCP breakers were originally designed for 40 kA. Siemens can increase this rating to 50 kA by adding line to ground capacitors. Many 169 245 kV TCP breakers were originally designed for 50 kA. Siemens can increase this rating to 63 kA by adding line to ground capacitors
