As good as new: Siemens TLM success

HVDC converter transformer repair

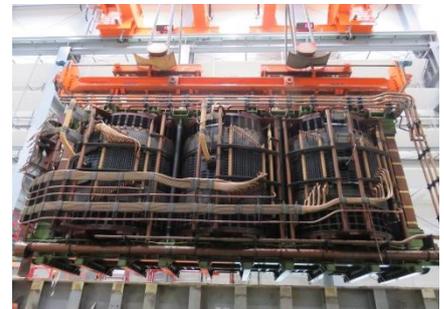
The dimensions of the unit are enormous, and a weight of 360 t meant a logistical challenge for everyone involved. The picture shows the active part is being removed from the tank.

The old insulating oil was drained and all components of the active part were checked for metal residue and other damage. After the repair, the converter was filled with new oil. Several cycles of oil processing and filtration were performed to make sure no metal residue would create operational risks for the repaired unit.

After repairing the faulty winding, the active part was re-assembled and the bushings were installed. The transformer was then filled with new insulation oil. However, to ensure a perfect repair, all copper particles from the old impregnated windings were removed and a special filtering process with several oil processing cycles was put in place.
