Your fire sprinkler system passed its annual testing, **but will water flow to a fire** in an emergency?

NFPA 25, Chapter 14: Internal Piping Condition and Obstruction Investigation

Siemens Internal Piping Condition and Obstruction Investigation Service

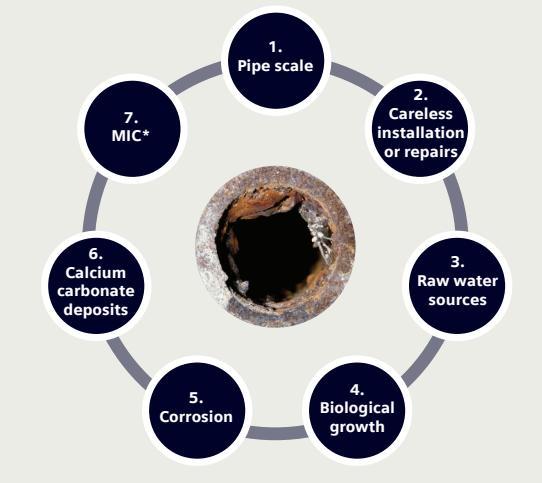
NFPA 25 Annex D – Seven Sources of Obstructions

- 1. Dry pipe systems are particularly susceptible to scale that flakes off into the pipes.
- 2. Gravel, sand, debris, and objects such as gloves and metal shavings enter pipes.
- 3. Stones, sticks, mud, etc. enter the system when water intake screens are not properly installed.
- 4. Larvae and small clams enter and attach to piping and then feed on bacteria and algae.
- 5. Hard water with high concentrations of calcium and magnesium form deposits.
- 6. Chemical and electrochemical reactions cause metal to deteriorate.
- 7. Microorganisms typically produce colonies that continue to grow and compromise throughput.

*Microbiologically Influenced Corrosion (MIC)
