## 主题: G120XA 侧边外壳表面温度偏高说明

G120XA 外壳过热

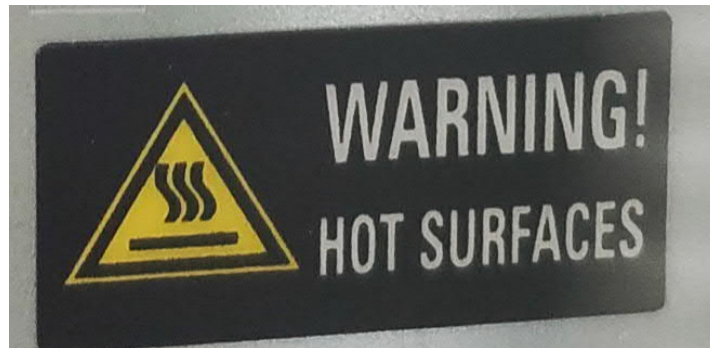
根据 IEC 60417 和 W017-SIO 要求, 在塑料外壳温度超过 80°C, 需要在外壳粘贴警示标签。G120XA 的警示标签如图所示。在长时间待机情况下, G120XA 侧边温度会超过 80°C, 这是正常现象, 不影响客户使用。

由于 G120XA 内部的电路布局原因, 其开关电源变压器靠近侧边的塑料外壳。在待机状态下, 变压器一直处于通电状态会产生热量, 而此时内部风扇不工作导致热量散不出。这样会让靠近变压器的侧边外壳温度上升。

但是考虑到高温对元器件寿命性能的影响, 手册上规定了 G120XA FSA FSB FSC 的安装要求如下:  
For tolerance reasons, we recommend a lateral clearance of approx. 1 mm. For converters FSA ... FSC, the side-by-side mounting (with 0 mm lateral clearance) allows a maximum surrounding air temperature during operation of 55 °C; in case of the surrounding air temperature higher than 55 °C, a lateral clearance of 50 mm or greater is required.

也就是说, 对于环境温度超过 55 °C 应用, 建议 G120XA 变频器并排安装间隙大于 50mm。
